VARIANCE REQUEST

**AN ASBESTOS SURVEY AND ASSESSMENT
FOR THE
DESERET TOWERS "W" HALL
BRIGHAM YOUNG UNIVERSITY
PROVO, UTAH**

July 7, 2006

**AN ASBESTOS SURVEY AND ASSESSMENT
FOR THE
DESERET TOWERS "V" HALL
BRIGHAM YOUNG UNIVERSITY
PROVO, UTAH**

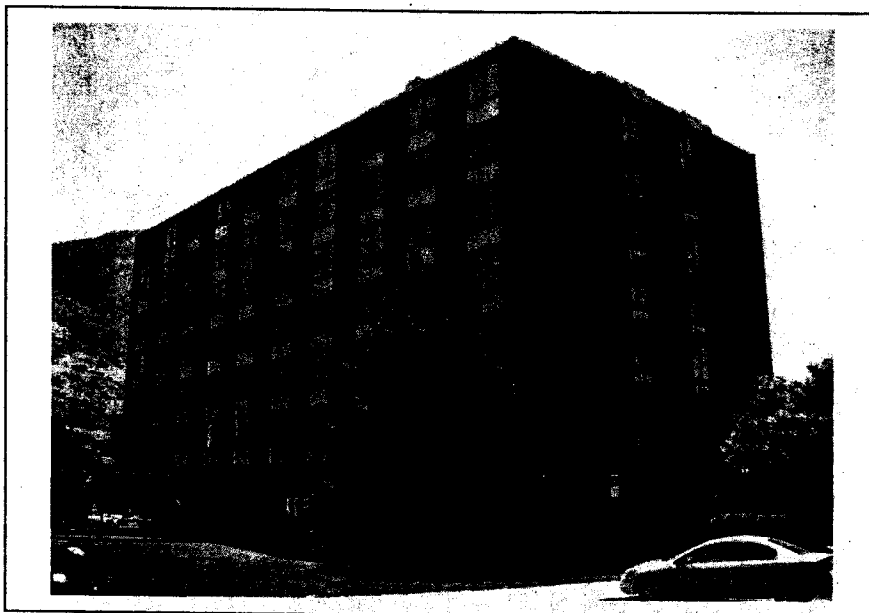
PHOTO 1

- 1. Exterior view of building looking southeast**
- 2. Textured ceiling material throughout the building contains asbestos**
- 3. Sink undercoating in the ironing room areas contains asbestos**
- 4. Vinyl floor tile contains asbestos**
- 5. Vinyl floor tile contains asbestos**

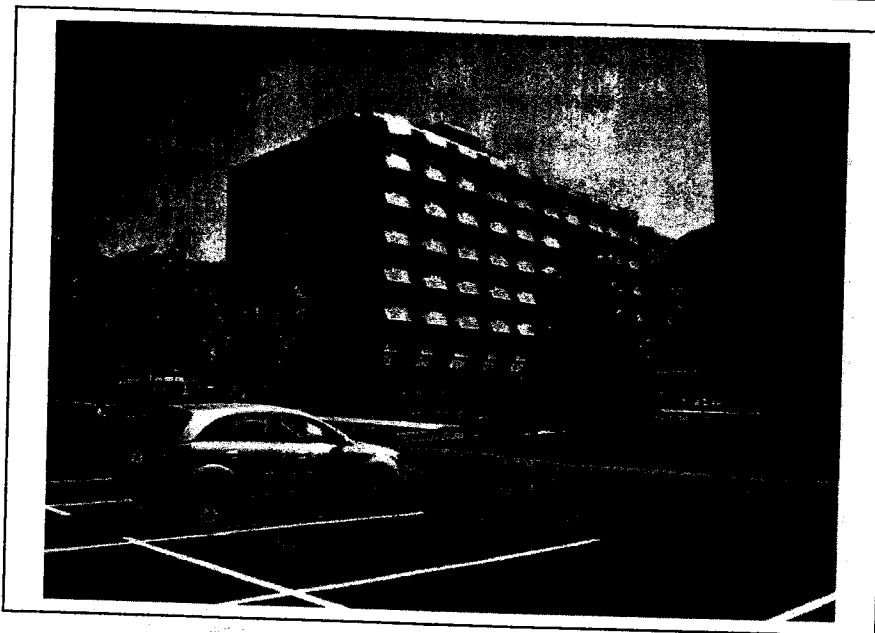
PHOTO 1

- 1. Exterior view of building looking Noutheast**
- 2. Textured ceiling material throughout the building contains asbestos**
- 3. Vinyl floor tile on stairway landings contains asbestos**
- 4. Sink undercoating in the ironing room area contains asbestos**
- 5. Sink undercoating in the first floor manager's residence contains asbestos**
- 6. Thermal System Insulation mudded fittings throughout the building contains asbestos**
- 7. Thermal System Insulation mudded fittings throughout the building contains asbestos**
- 8. Thermal System Insulation mudded fittings throughout the building contains asbestos**
